STAFF SUBMITTAL  
for the meeting of the  
COMMISSION ON WATER RESOURCE MANAGEMENT

December 17, 2008  
Honolulu, Hawaii

After-the-Fact Application for a Stream Channel Alteration Permit (SCAP.2061.3)  
Emergency Stabilization of DOT Pedestrian Bridge across Kapaka/Waimanana Stream  
Hauula, Oahu, TMK: (1) 5-3-014:003

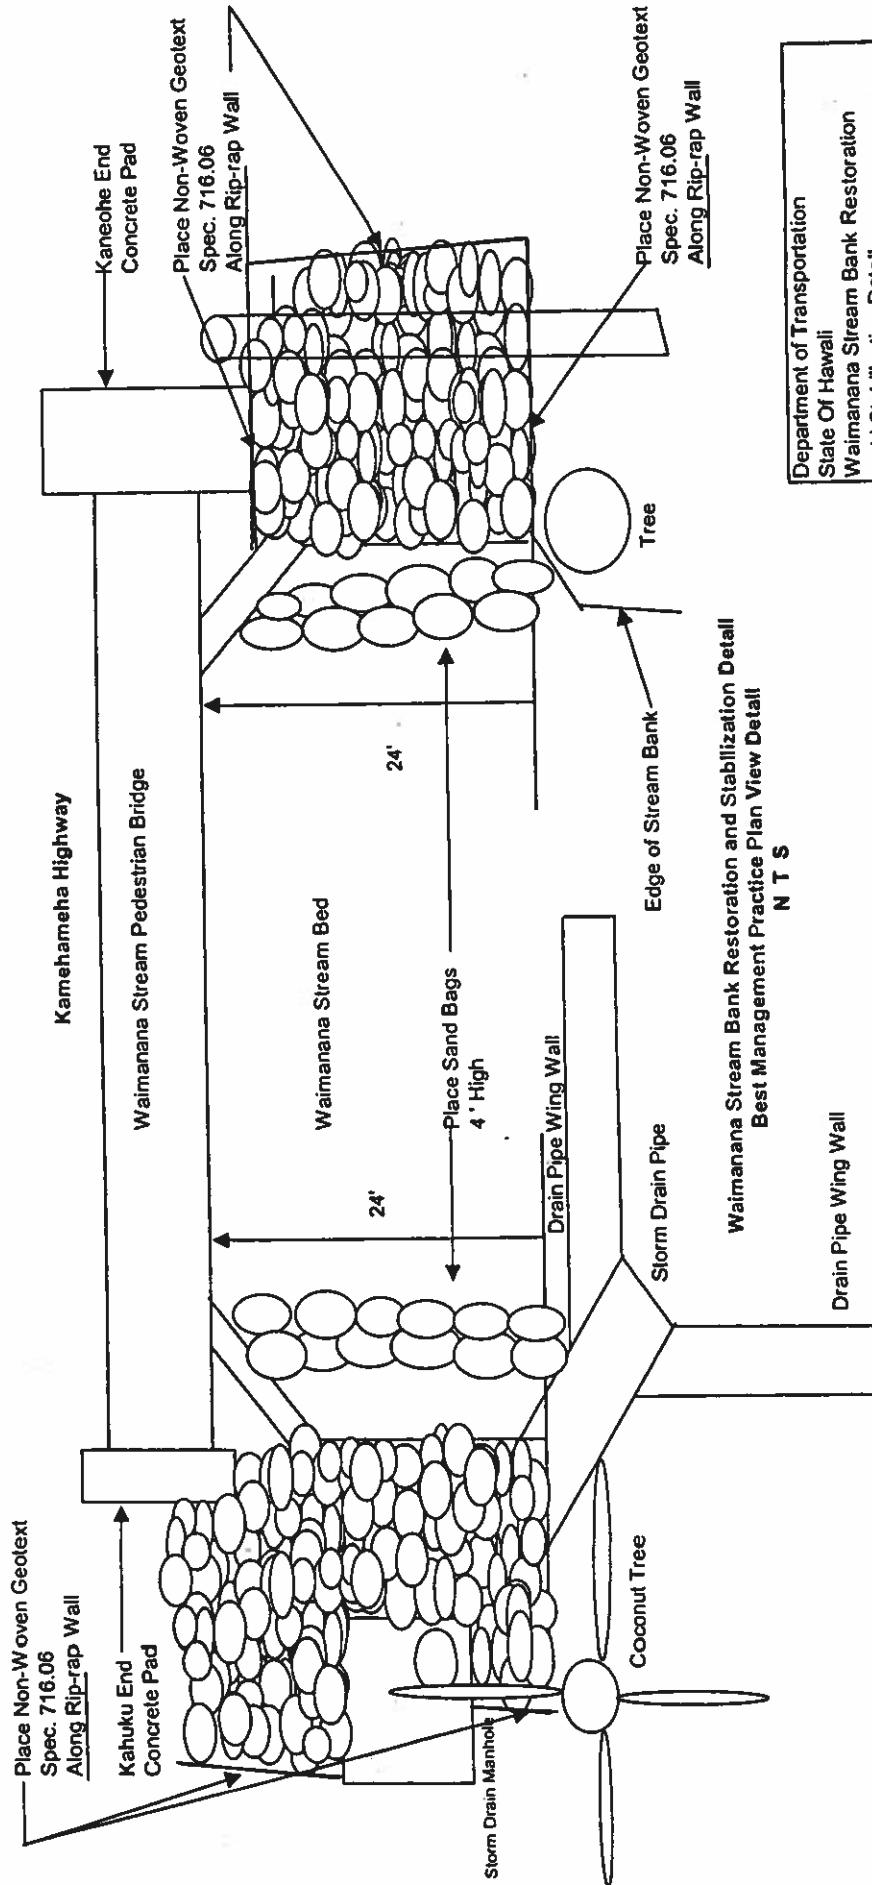
Department of Transportation  
 State Of Hawaii  
 Waimanana Stream Bank Restoration  
 and Stabilization Detail  
 Date: August 22, 2008 Page 2

Phase 2 of the project involved the placement of approximately 56 cubic yards of small to medium-size boulders under the pedestrian bridge and along the adjacent streambank at both ends of the pedestrian bridge to stabilize the support structure under the pedestrian bridge and the streambank. Approximately 15 cubic yards of concrete were used to fill in the voids between the boulders.

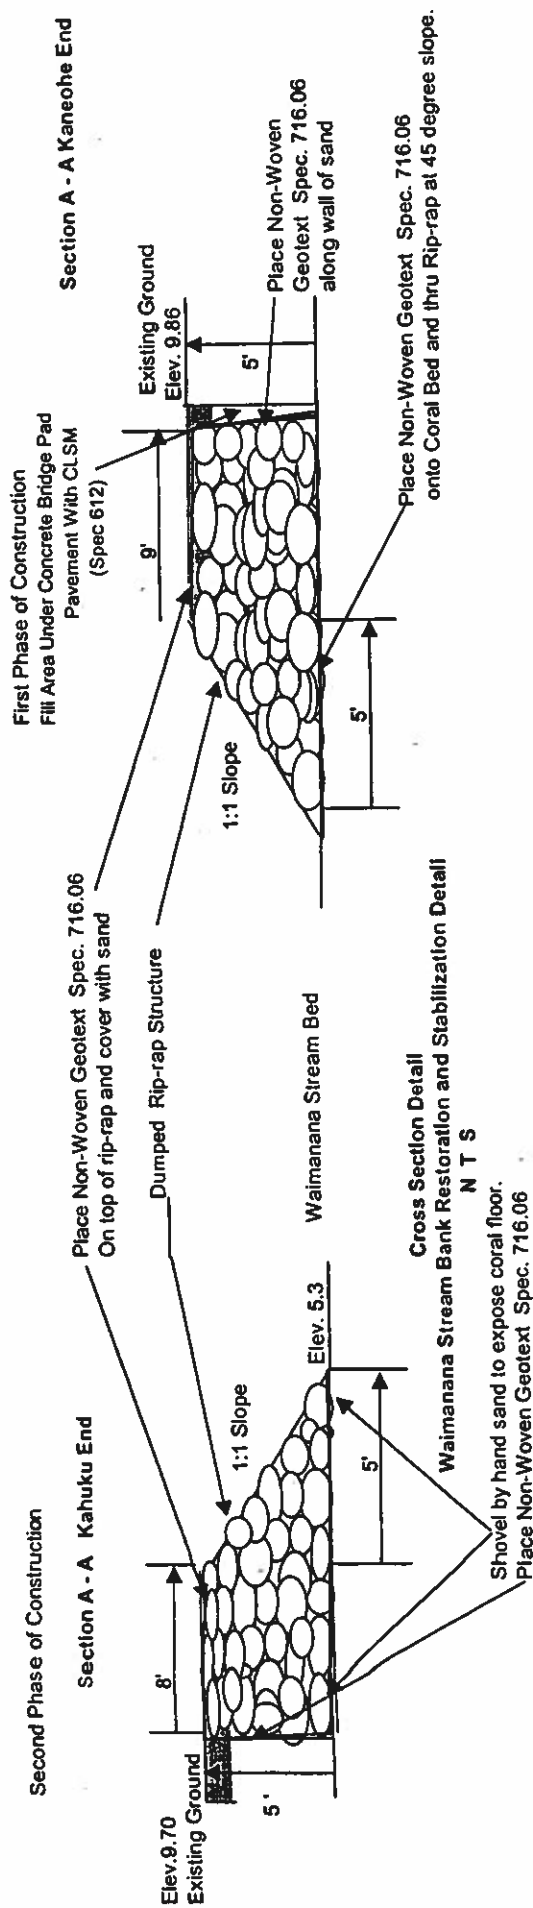
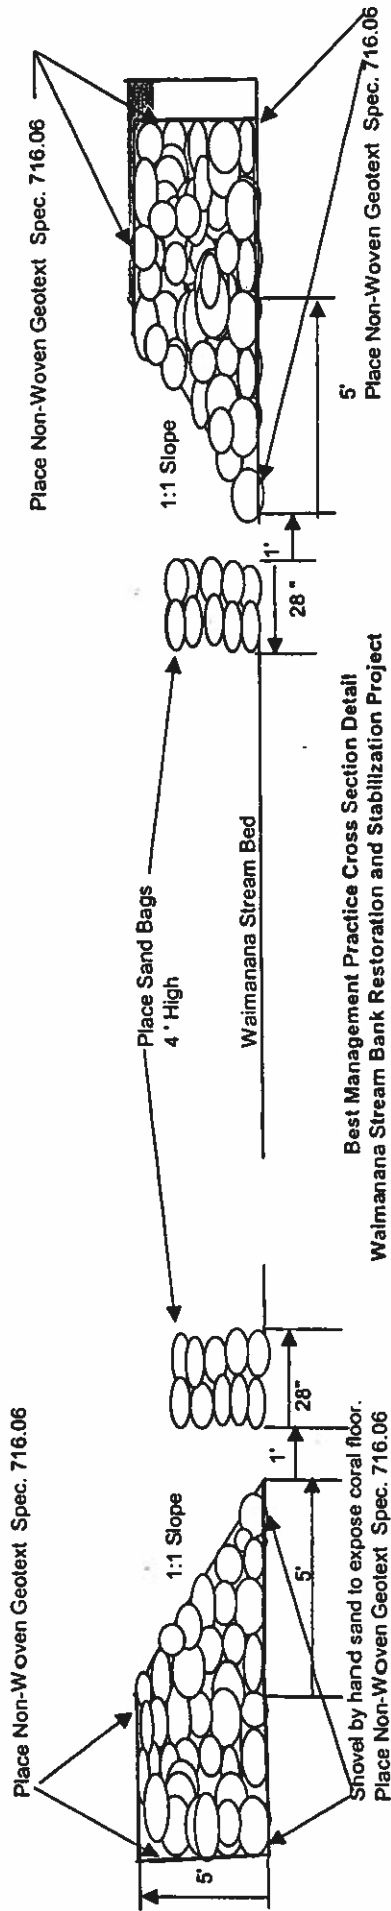
Department of Transportation  
State Of Hawaii  
Waimanana Stream Bank Restoration  
and Stabilization Detail  
Date: August 22, 2008

Volume of Sand Bag Berm  
 Size of Sand bag  
 Volume of Sand Bag  
 Number of Sand bags for berm

24'X4'X28" = 224 cu ft  
 14" dia. X 26"  
 1.07 sq ft X 2.16 ft = 2.31 cu ft  
 224 cu ft / 2.31 cu ft = 97 bags

Phase 1 of the project involved the temporary placement of sandbags around the pedestrian bridge to isolate the work area while boulders were placed under the pedestrian bridge and along the streambank.
